MEMORANDUM

SUBJECT: Richardson Flat Tailings Site Visit, August 4-6, 1992

On August 4-6, 1992 representatives from EPA and EPA's technical assistance team of Ecology and Environment, Inc. (TAT) conducted sampling at the Richardson Flat Tailings Site in Summit County Utah (the Site). The purpose of this sampling was to assess the need for possible removal or site stabilization at the Site. During this activity, observations were made on behalf of EPA's site assessment program to attempt to resolve issues associated with the Hazard Ranking System Scoring Package (HRS package) for the Site. This memo provides a report of the those observations.

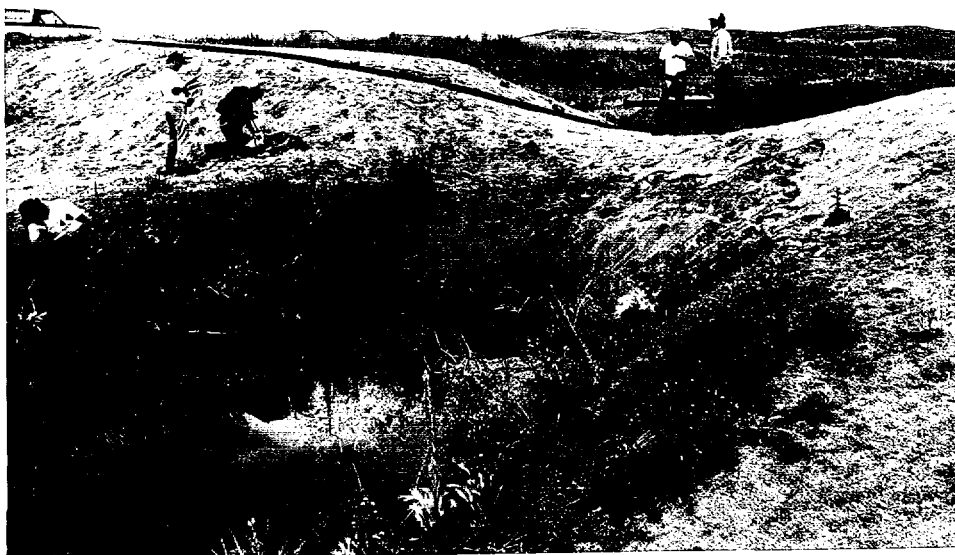
PHOTO #1

measuring. The first XRF measurement, number RF 051, was taken from the northwest shoulder of the slurry pipe support (see photo #1). The XRF "shot" was taken on the surface, in-situ, at 1433 hrs. The surface material was what appeared to be silica sand. The XRF reading for RF 051 was 1.5 parts per million (ppm) total relative lead concentration (because the x-met was not calibrated to the Site soils, only relative total lead concentrations were measured) (see photo #1). A second measurement was taken, number RF 052, at a location immediate adjacent to RF 051. The "shot" was also taken on the surface, in-situ, at 1435 hrs. The XRF reading for RF 052 was 0.0 ppm. A third reading was taken, RF 053, at a location approximately four feet north of standing water on the bank of the diversion ditch (see photo #2). The soil at this location was a dark loam to coarse clay material and appeared to be a native soil. It did not exhibit typical physical characteristics of mill tailings. The "shot" was taken approximately 2" below the ground surface, in situ, at 1437 hrs. The XRF reading for RF 053 was 6326 ppm. A fourth reading was taken, RF 054, of a lead calibration standard of known total lead concentration equal to 1000 ppm. RF 054 was taken at 1440 hrs. The reading for RF 054 was 1122 ppm. All XRF measurements were made by Katherine Romine of the TAT.

SUBJECT: Slurry line diversion ditch crossing. TAT member is analyzing sample RF-051 using X-MET XRF instrument. XRF reading 0.0 ppm "Relative Total Lead Concentration".

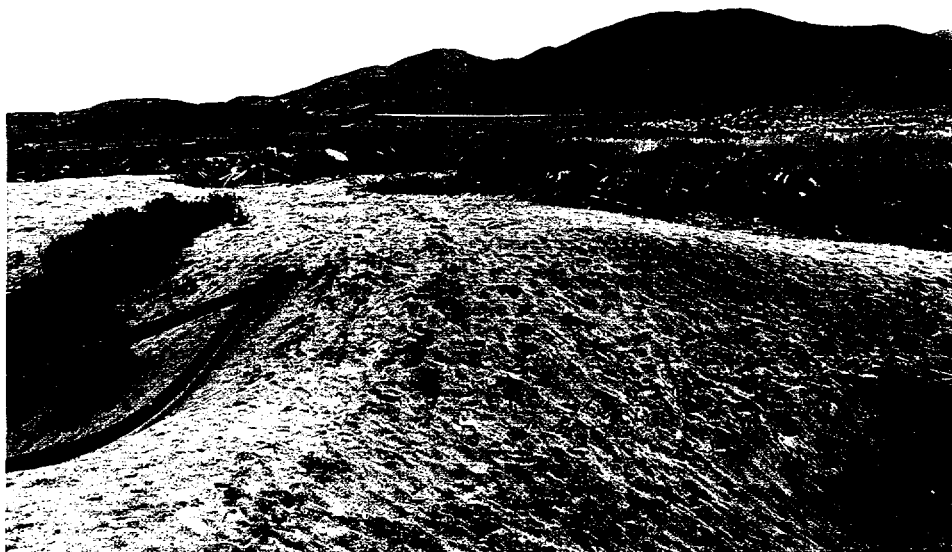
PHOTO #3

SUBJECT: Looking southerly from diversion ditch crossing.

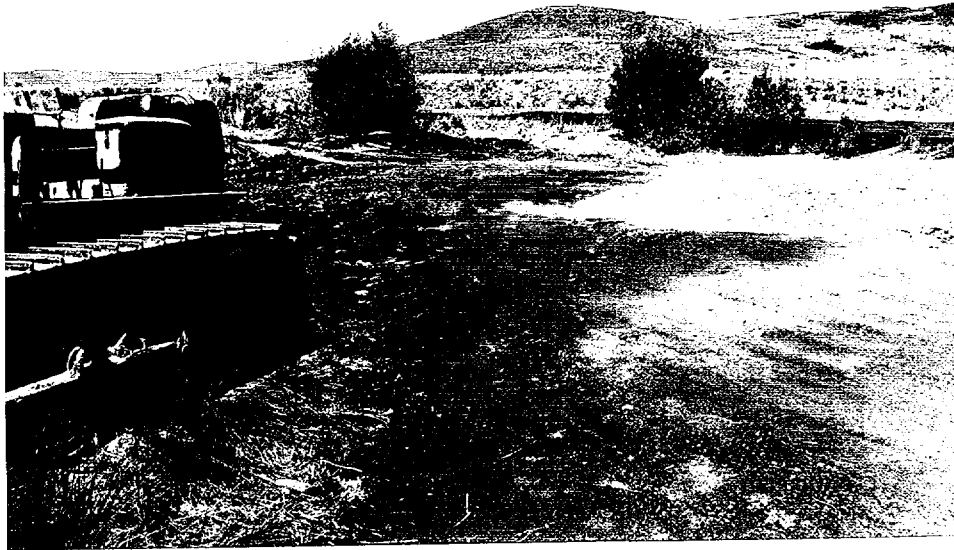
PHOTO #5

SUBJECT: Apparent location of RFT-TA3. Facing toward diversion ditch. Note thin cover material (dark soil) on top of tailings (grey material).

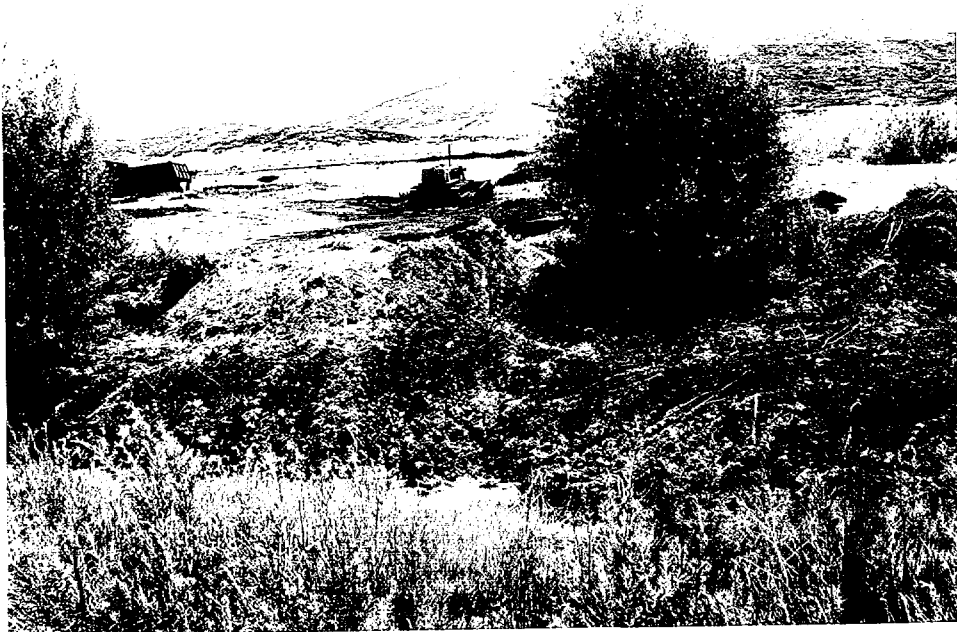
PHOTO #6

During and following the sampling and analysis McCeney photo documented the crossing area and the apparent location of RFT-TA3. McCeney paced and compassed the apparent location of RFT-TA3 as being approximately 100 feet southerly from the diversion ditch. McCeney observed that tailings material was present in an area surrounding the sample location (see photos # 4,5, and 6). Some fill activity had taken place north of the sample location, in an area extending to the diversion ditch. However, McCeney observed that, in places, tailings were mixed with the fill. McCeney also observed tailings mixed with the fill on the south bank of the diversion ditch. McCeney and Zimmerman observed that this mixture of tailings and fill extended into the standing water of the diversion ditch. (see photo #6).

SUBJECT: From north bank of diversion ditch toward apparent location of RFT-TA3. Note tailings mixed with fill on south bank of diversion ditch.
